**Flood Control Project Maintenance  
Levee Inspections****LMA District Cover Sheet****Spring 2015 Levee Inspection Results****Reclamation District No. 0003 Grand Island**

**Spring 2015 Levee Inspection Results**

**Reclamation District No. 0003 Grand Island**

**Levee Inspection Report By Mile - Spring 2015**

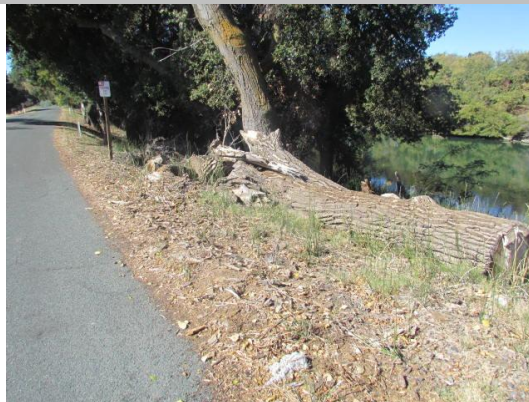
Photo 1 of 2 : SP\_2015\_RD0003\_24\_19\_20150309\_00018.jpg

Looking west at tree branch on waterward shoulder and slope. (Fall 2014)

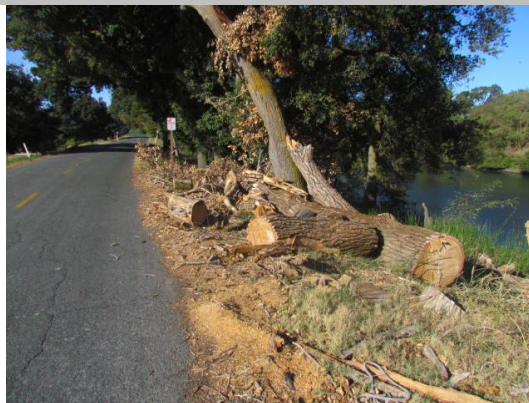
Photo 2 of 2 : SP\_2015\_RD0003\_24\_19\_20150309\_00019.jpg

Looking south at tree branches on waterward shoulder. (Spring 2014)

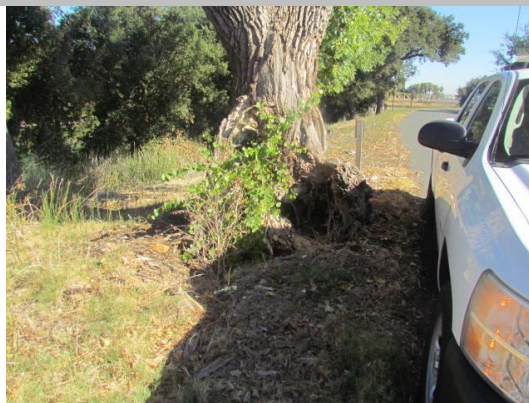
Photo 1 of 3 : SP\_2015\_RD0003\_24\_2\_20150309\_00001.jpg

LM Start	0.13	Rating **	M	Issue No.	2
LM End	0.13	Issue Type +	Ma	Location *	WS
Category	Earthen Levee			GPS Latitude/Longitude	
				Start	End
Item	Erosion / Bank Caving			38.303303 °	38.303303 °
				-121.576538 °	-121.576538 °
DWR ID	DWR_RD0003_01_f_2013_2				
Action/Comments					
Schedule repair of erosion site prior to the next inspection. Inspector Comments: Hole (8ft x 2.5ft x 5ft) next to a large tree on waterward shoulder.

Looking east at hole at base of tree on waterward shoulder. (2014)

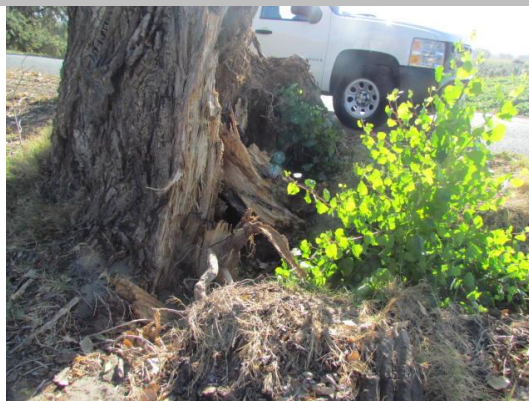
Photo 2 of 3 : SP\_2015\_RD0003\_24\_2\_20150309\_00002.jpg

Looking east at a hole next to oak tree on waterward shoulder.

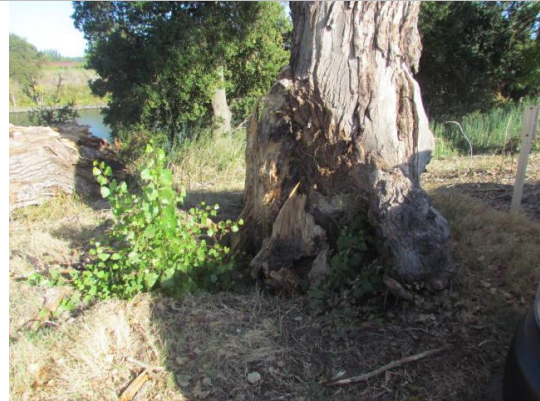
Photo 3 of 3 : SP\_2015\_RD0003\_24\_2\_20150309\_00003.jpg

LM Start	0.13	Rating **	M	Issue No.	2 (cont)	
LM End	0.13	Issue Type +	Ma	Location *	WS	
Category	Earthen Levee			GPS Latitude/Longitude		
				Start	End	
Item	Erosion / Bank Caving			38.303303 °	38.303303 °	
				-121.576538 °	-121.576538 °	
DWR ID	DWR_RD0003_01_f_2013_2					
Action/Comments						
Schedule repair of erosion site prior to the next inspection. Inspector Comments: Hole (8ft x 2.5ft x 5ft) next to a large tree on waterward shoulder.

Looking west at a hole next to oak tree on waterward shoulder.

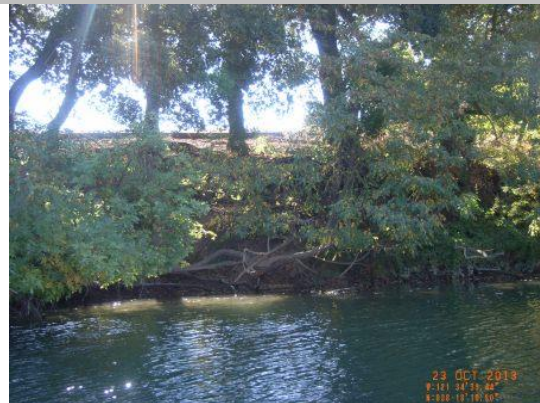
Photo 1 of 1 : SP\_2015\_RD0003\_24\_14\_20150309\_00014.jpg

LM Start	0.18	Rating **	M	Issue No.	14
LM End	0.24	Issue Type +	Ma	Location *	WS
Category	Supplemental			GPS Latitude/Longitude	
				Start	End
Item	USACE Erosion Survey			38.303035 °	38.302544 °
				-121.577357 °	-121.578241 °
DWR ID	DWR_RD0003_01_f_2014_14				
Action/Comments					
Inspector Comments: 1997 - Mass failure of berm slope and wave wash erosion. Large trees on top of berm, some failed trees. New area of low rock to on the upstream end. 2000 - Some minor erosion near the downstream end. 2005 - One new small tree has fallen. 2009 - Minimal new erosion. 2010 - Minor new erosion. 2013: Observed new animal holes and vertical sections at middle of site. [2013 Site ID: STM_26-0_L]

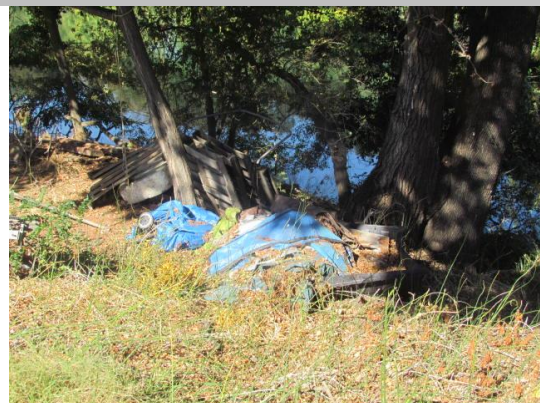
Photo 1 of 4 : SP\_2015\_RD0003\_24\_188\_20150309\_00078.jpg

LM Start	0.21	Rating **	M	Issue No.	188
LM End	0.21	Issue Type +	En	Location *	WS
Category	Earthen Levee			GPS Latitude/Longitude	
				Start	End
Item	Encroachments			38.302625 °	38.302625 °
				-121.577683 °	-121.577683 °
DWR ID	DWR_RD0003_01_s_2012_188				
Action/Comments					
Garbage					
Inspector Comments: Landowner has piled wooden boards and trash on waterside berm.

Looking southwest at garbage on waterward berm. (Fall 2014)

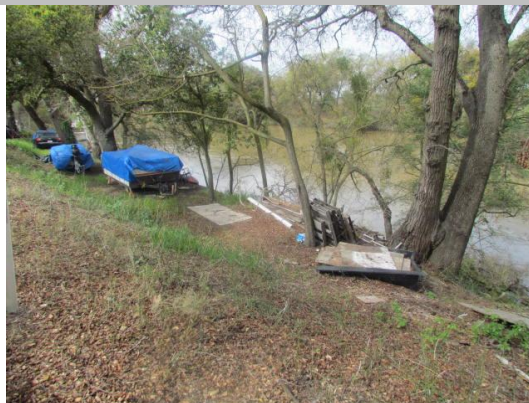
Photo 4 of 4 : SP\_2015\_RD0003\_24\_188\_20150309\_00081.jpg

Looking southwest at trash on waterside berm. (Spring 2014)

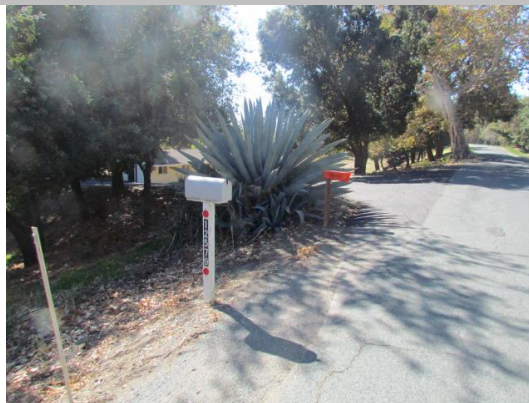
Photo 1 of 2 : SP\_2015\_RD0003\_24\_22\_20150309\_00023.jpg

Looking south at century plant on landward shoulder.(Fall 2014)

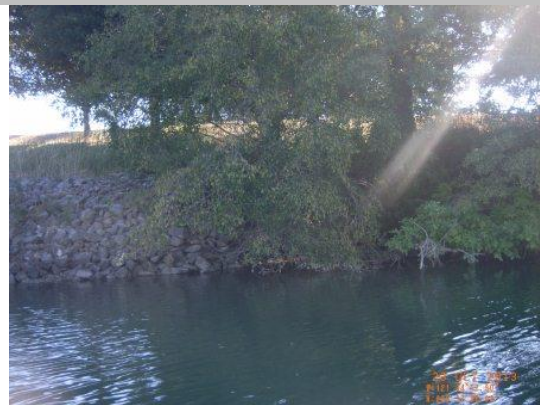
Photo 1 of 1 : SP\_2015\_RD0003\_24\_10\_20150309\_00010.jpg

LM Start	0.91	Rating **	M	Issue No.	10
LM End	0.96	Issue Type +	Ma	Location *	WS
Category	Supplemental			GPS Latitude/Longitude	
				Start	End
Item	USACE Erosion Survey			38.293386 °	38.292675 °
				-121.582554 °	-121.582741 °
DWR ID	DWR_RD0003_01_f_2014_10				
Action/Comments					
Inspector Comments: 1997 - Erosion of sandy levee on top left bank. Site is downstream of a rock section. Large riparian trees on the bank. 1999 - Upstream half of the reach repaired with rock, except for a 30 ft reach at the upstream end. 2001 - Rock repair on the upstream and downstream ends; no revetment at the trees. 2002 - Rock repair is starting to slide off the geotextile at the upstream end. 2005 - One new small tree has fallen. 2006 - 50 ft pocket at the downstream end and at the upstream end with new rock in between. 2007 - Upstream end has been repaired. 2010 - Some minor new erosion. 2011 - Minor new erosion. 2012 - Minor new erosion at the toe. 2013: No observed changes. [2013 Site ID: STM_25-0_L]

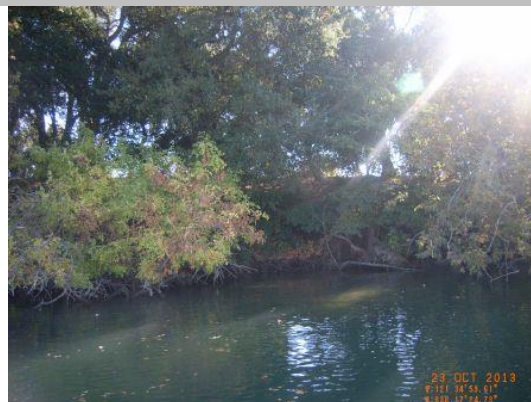
Photo 1 of 2 : SP\_2015\_RD0003\_24\_4\_20150309\_00004.jpg

LM Start	1.03	Rating **	M	Issue No.	4
LM End	1.18	Issue Type +	Ma	Location *	WS
Category	Supplemental			GPS Latitude/Longitude	
				Start	End
Item	USACE Erosion Survey			38.291695 °	38.289575 °
				-121.582993 °	-121.583092 °
DWR ID	DWR_RD0003_01_f _ 2014_4				
Action/Comments					
Inspector Comments: 2008 - Area closed sign on bank. Newly fallen trees at both ends and pop outs along the bank. 2010 - Site extended downstream. 2011 - New erosion at the toe. More trees popouts. 2013: Short vertical sections observed at the downstream end. [2013 Site ID: STM_24-8_L]

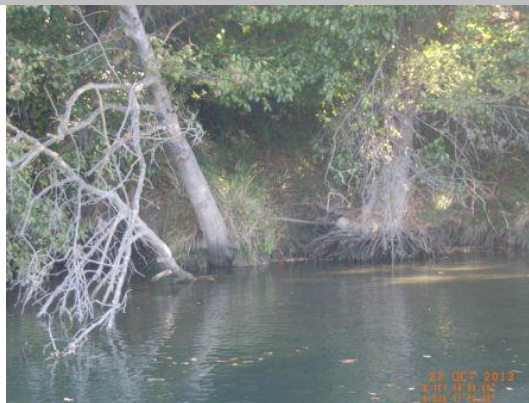
Photo 2 of 2 : SP\_2015\_RD0003\_24\_4\_20150309\_00005.jpg

LM Start	1.03	Rating **	M	Issue No.	4 (cont)	
LM End	1.18	Issue Type +	Ma	Location *	WS	
Category	Supplemental			GPS Latitude/Longitude		
				Start		End
Item	USACE Erosion Survey			38.291695 °	38.289575 °	
				-121.582993 °	-121.583092 °	
DWR ID	DWR_RD0003_01_f_2014_4					
Action/Comments						
Inspector Comments: 2008 - Area closed sign on bank. Newly fallen trees at both ends and pop outs along the bank. 2010 - Site extended downstream. 2011 - New erosion at the toe. More trees popouts. 2013: Short vertical sections observed at the downstream end. [2013 Site ID: STM_24-8_L]

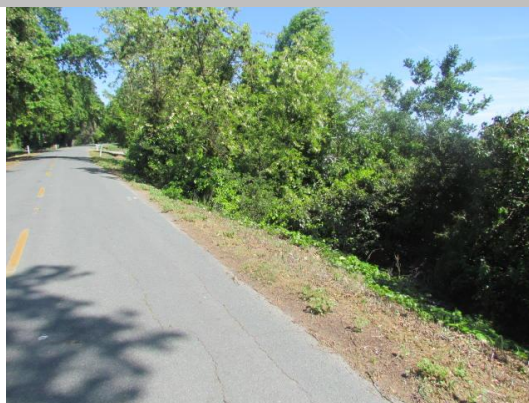
Photo 1 of 2 : SP\_2015\_RD0003\_24\_12\_20150309\_00011.jpg

Looking northeast at dense landscape on landward slope. (Spring 2013)

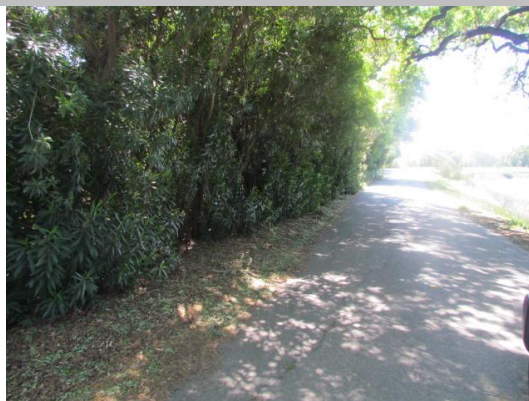
Photo 2 of 2 : SP\_2015\_RD0003\_24\_21\_20150309\_00022.jpg

Looking southeast at dense landscape (Oleanders) on landward shoulder and slope.

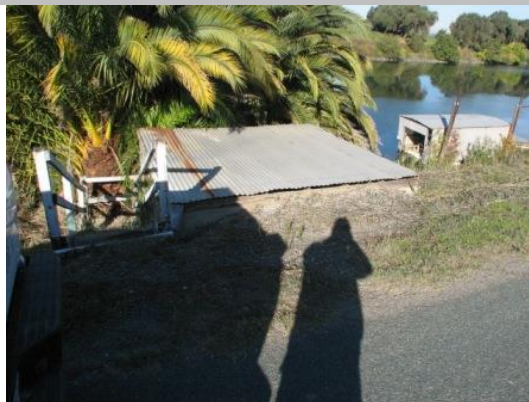
Photo 1 of 1 : SP\_2015\_RD0003\_24\_36\_20150309\_00042.jpg

Pipe penetration and pump shed on waterside slope.

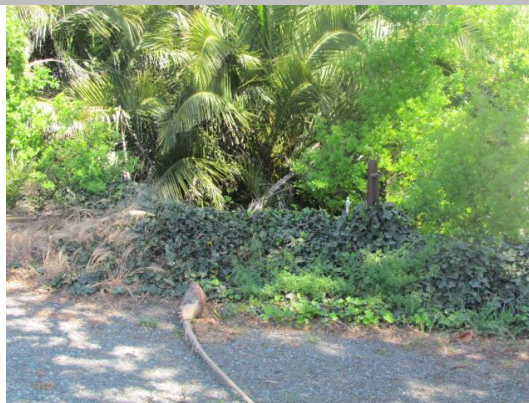
Photo 1 of 1 : SP\_2015\_RD0003\_24\_26\_20150309\_00030.jpg

Looking east at dense landscaping on landward slope.

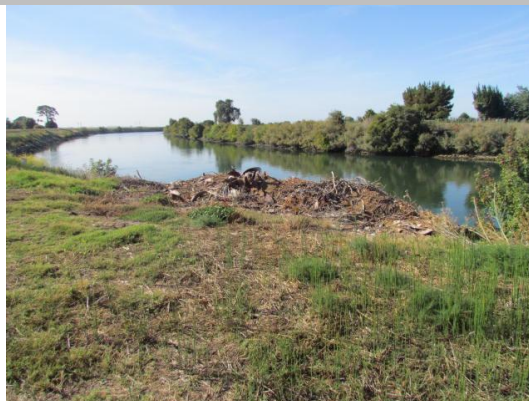
Photo 1 of 1 : SP\_2015\_RD0003\_24\_100\_20150309\_00072.jpg

Looking southwest at grass clippings on waterward berm.

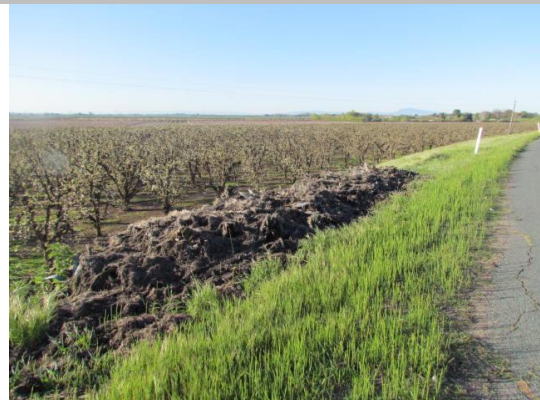
Photo 1 of 2 : SP\_2015\_RD0003\_24\_51\_20150309\_00048.jpg

Looking southeast at cactus mowed/removed by the district

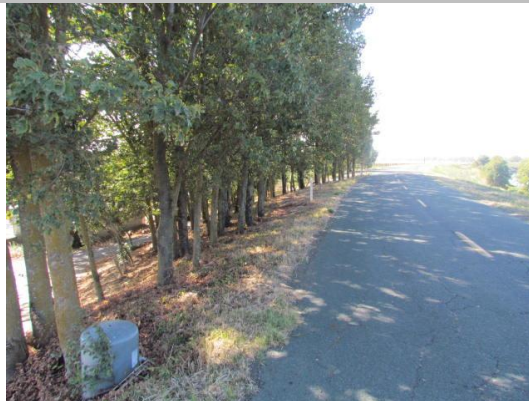
Photo 1 of 1 : SP\_2015\_RD0003\_24\_9\_20150309\_00009.jpg

Looking southeast at trees on landward shoulder and slope.

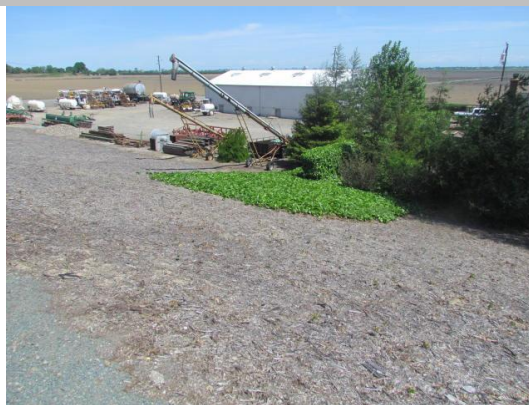
Photo 1 of 1 : SP\_2015\_RD0003\_24\_50\_20150309\_00047.jpg

Looking northeast at landscaping at lower half of landward slope and toe.

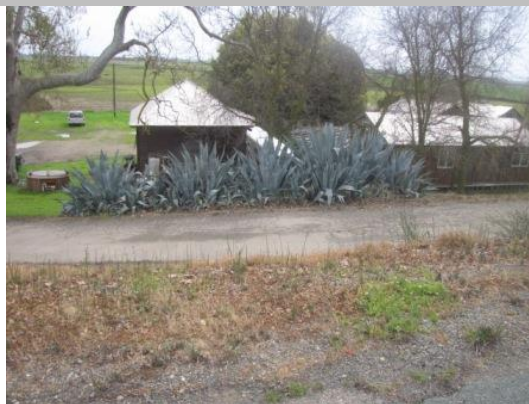
Photo 2 of 2 : SP\_2015\_RD0003\_24\_61\_20150309\_00053.jpg

Looking west at century plants on landside slope next to ramp.

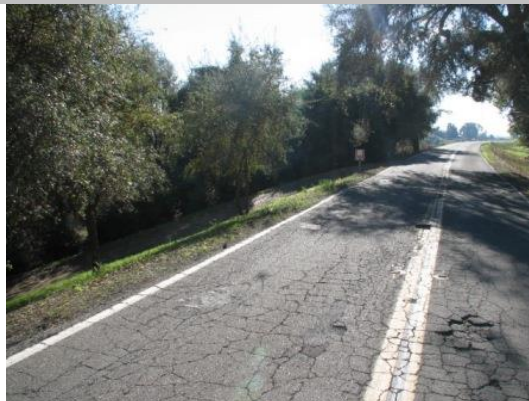
Photo 2 of 2 : SP\_2015\_RD0003\_24\_64\_20150309\_00055.jpg

Landscaping on levee slope and within 10' of levee toe obstruct visibility and access.

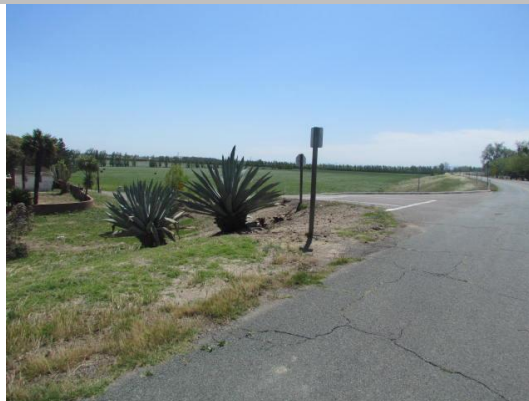
Photo 2 of 4 : SP\_2015\_RD0003\_24\_23\_20150309\_00027.jpg

Looking southeast after landowner removed cactus plant on landward shoulder. (Spring 2014)

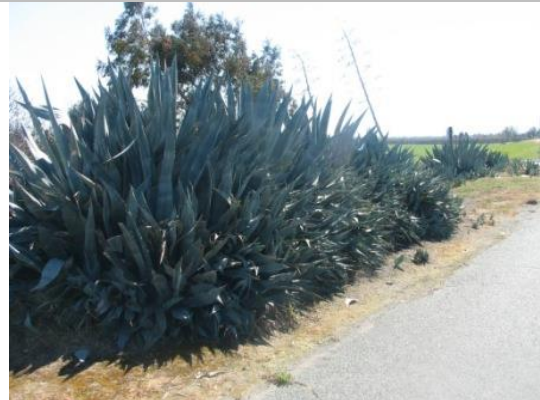
Photo 4 of 4 : SP\_2015\_RD0003\_24\_23\_20150309\_00025.jpg

Large cactus plant on landside shoulder block view of levee slope from LM 7.08 to 7.10.

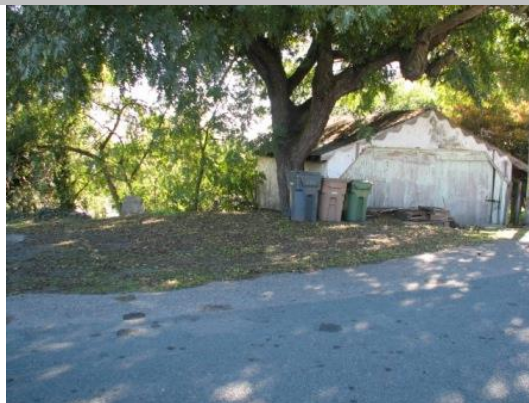
Photo 1 of 1 : SP\_2015\_RD0003\_24\_74\_20150309\_00058.jpg

Buildings obstruct access and visibility of levee slope and toe.

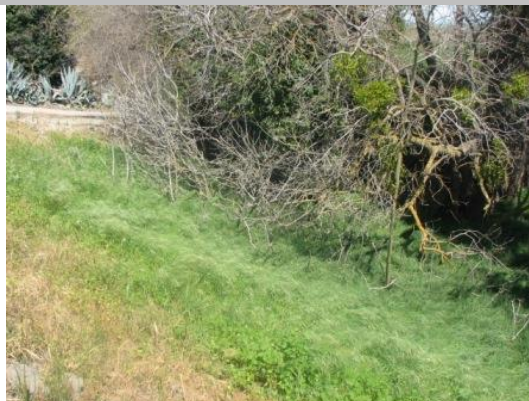
Photo 1 of 2 : SP\_2015\_RD0003\_24\_971\_20150309\_00082.jpg

Side view of dense trees at landside toe.

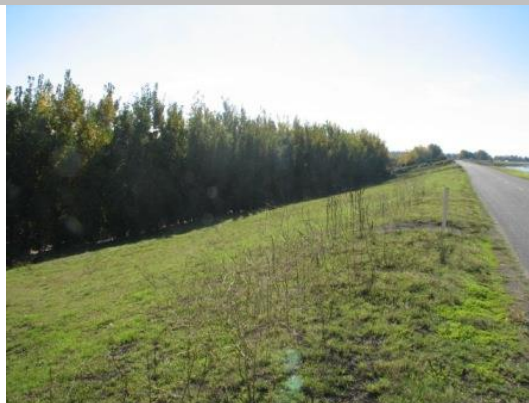
Photo 1 of 1 : SP\_2015\_RD0003\_24\_78\_20150309\_00060.jpg

Trees within 10' of levee toe obstruct access and visibility of levee toe.

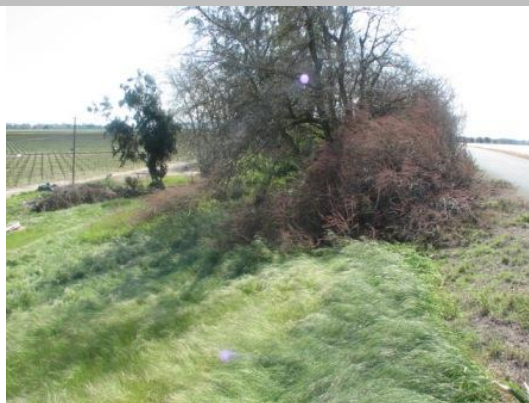
Photo 3 of 3 : SP\_2015\_RD0003\_24\_27\_20150309\_00033.jpg

Side view of trees on landside shoulder.

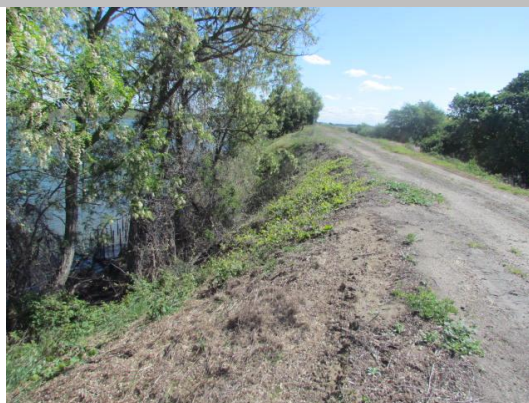
Photo 1 of 3 : SP\_2015\_RD0003\_24\_98\_20150309\_00067.jpg

Looking north at erosion on waterward slope.

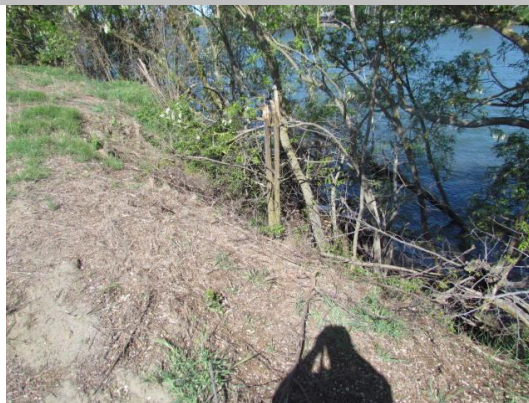
Photo 3 of 3 : SP\_2015\_RD0003\_24\_98\_20150309\_00069.jpg

Looking west at erosion on waterward slope.

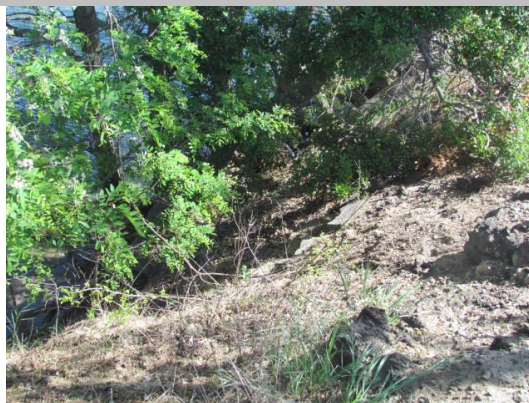
Photo 1 of 2 : SP\_2015\_RD0003\_24\_99\_20150309\_00070.jpg

Looking west at erosion on waterward slope.

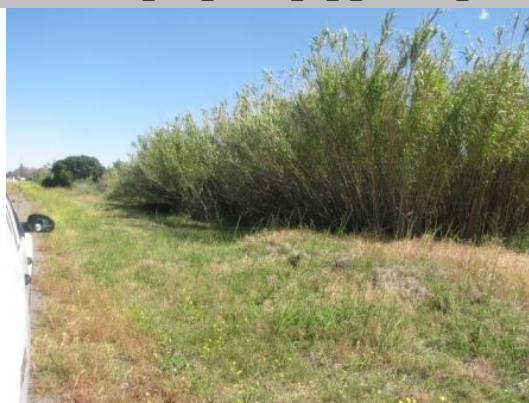
Photo 2 of 2 : SP\_2015\_RD0003\_25\_5\_20150309\_00007.jpg

Looking northeast at bamboo on waterside slope.

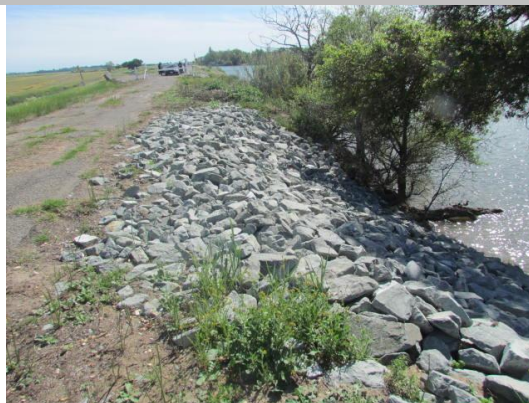
Photo 1 of 3 : SP\_2015\_RD0003\_25\_29\_20150318\_00088.jpg

Looking northeast at repaired site on waterward shoulder and slope.

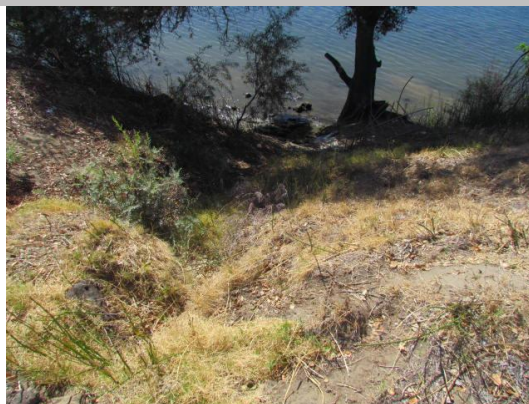
Photo 2 of 3 : SP\_2015\_RD0003\_25\_29\_20150309\_00027.jpg

Looking east at erosion that extends from waterward shoulder to waterward toe.

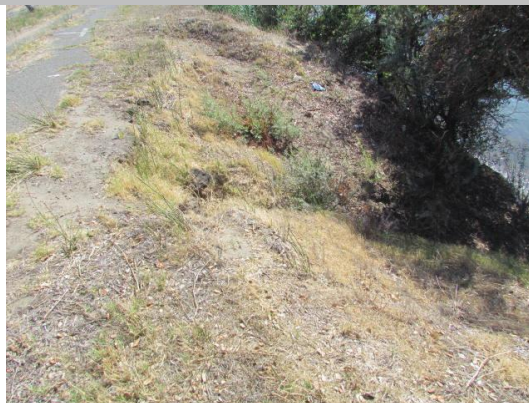
Photo 3 of 3 : SP\_2015\_RD0003\_25\_29\_20150309\_00028.jpg

Looking northeast at erosion on waterward slope and toe.

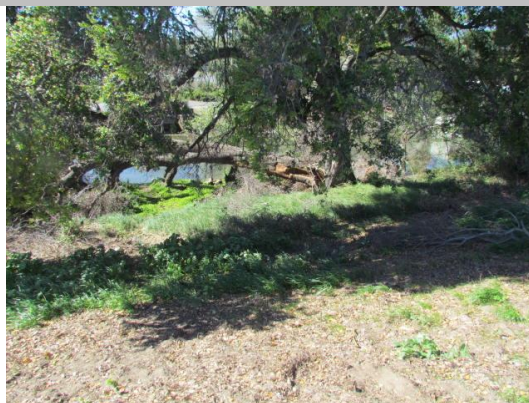
Photo 2 of 2 : SP\_2015\_RD0003\_25\_104\_20150309\_00079.jpg

Looking east at downed tree on waterward slope.

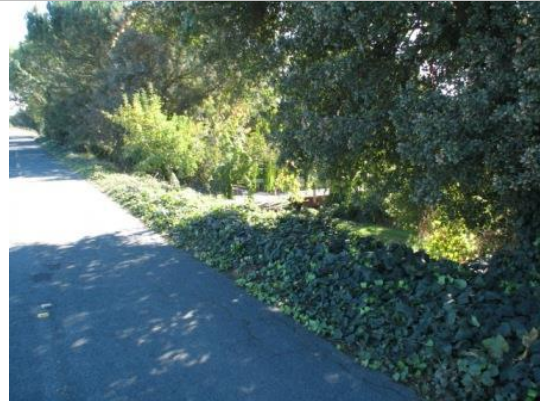
Photo 1 of 1 : SP\_2015\_RD0003\_25\_70\_20150309\_00052.jpg

Landscaping on levee slope obstructs visibility and access.

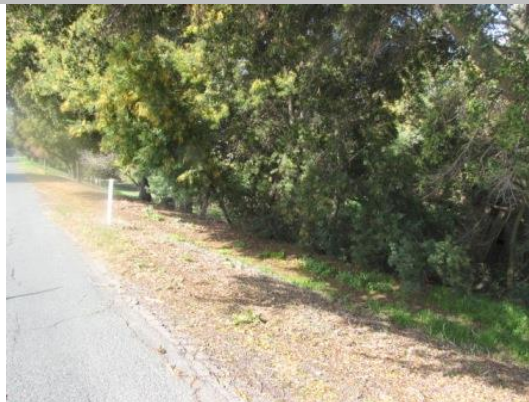
Photo 1 of 1 : SP\_2015\_RD0003\_25\_7\_20150309\_00008.jpg

Looking west at dense vegetation on landside slope and toe.

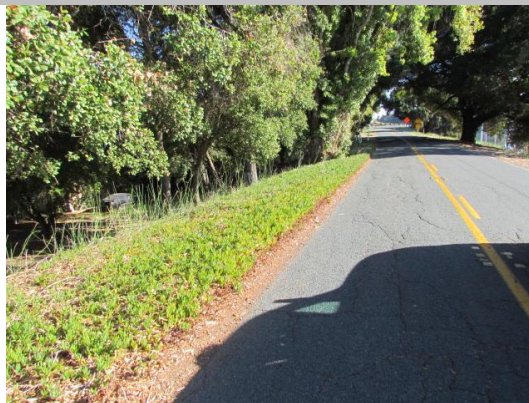
Photo 1 of 1 : SP\_2015\_RD0003\_25\_46\_20150309\_00039.jpg

Looking northwest at landscaping blocking view of landward slope.

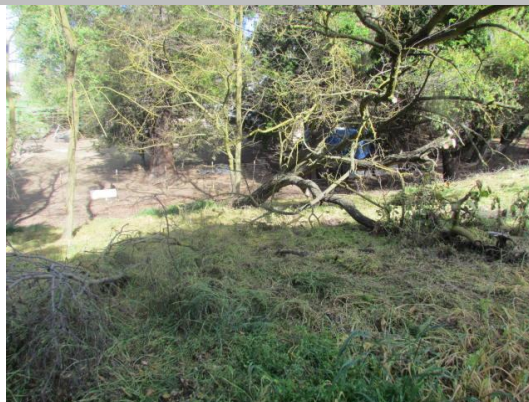
Photo 1 of 1 : SP\_2015\_RD0003\_25\_160\_20150318\_00089.jpg

Looking west at fallen tree on landward slope.

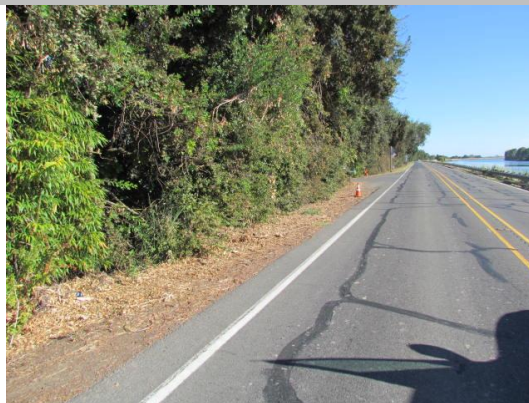
Photo 1 of 1 : SP\_2015\_RD0003\_25\_953\_20150309\_00086.jpg

Looking northwest at dense trees on landward shoulder and slope.

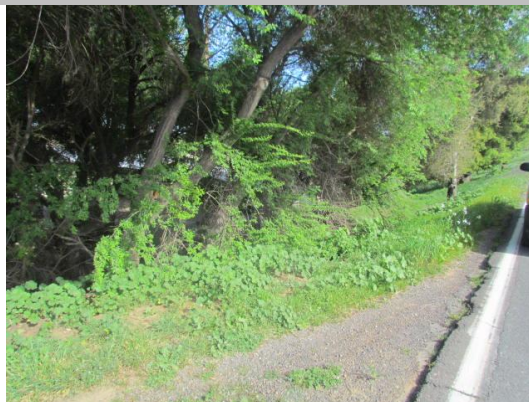
Photo 1 of 1 : SP\_2015\_RD0003\_25\_48\_20150318\_00090.jpg

Looking southwest at dense trees on landward slope.

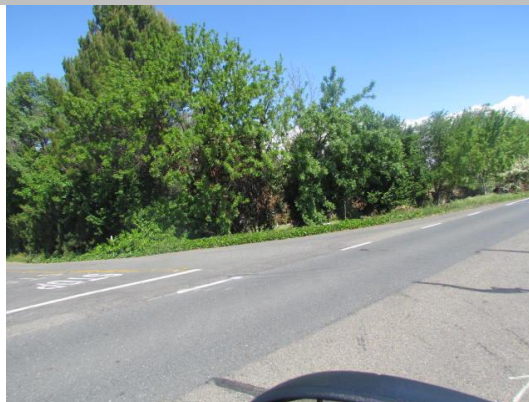
Photo 2 of 2 : SP\_2015\_RD0003\_25\_13\_20150309\_00017.jpg

Looking west at dense vegetation on landward slope.

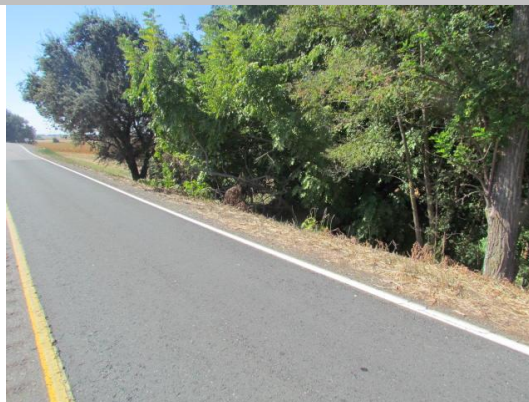
Photo 1 of 1 : SP\_2015\_RD0003\_25\_14\_20150309\_00018.jpg

Looking southwest at untrimmed trees on landward toe.

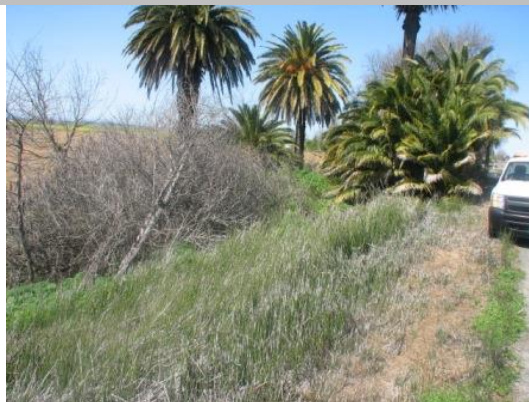
Photo 1 of 3 : SP\_2015\_RD0003\_25\_12\_20150309\_00013.jpg

Dense trees at landside toe and shoulder.

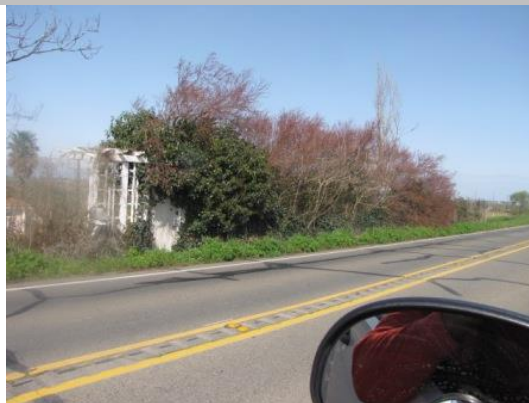
Photo 1 of 1 : SP\_2015\_RD0003\_25\_55\_20150309\_00042.jpg

Looking northwest a dense landscaping on landside shoulder and slope.

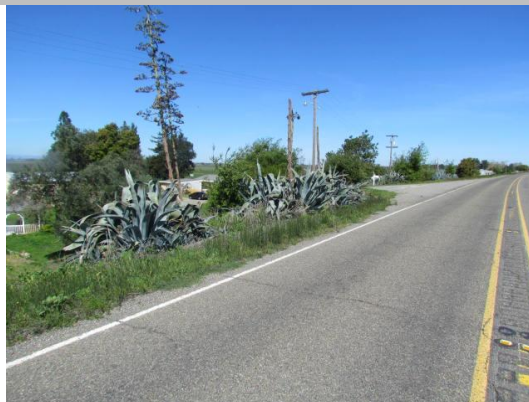
Photo 1 of 2 : SP\_2015\_RD0003\_25\_56\_20150309\_00043.jpg

Looking northwest at century plants on landside shoulder and slope.

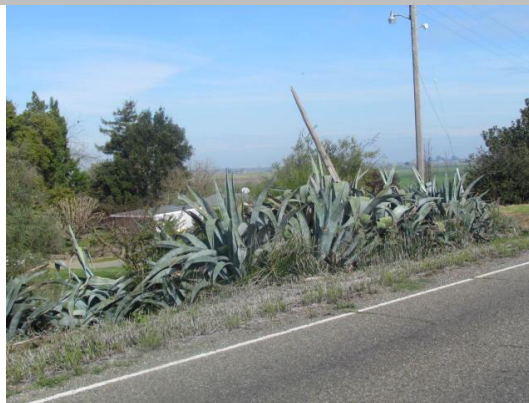
Photo 2 of 2 : SP\_2015\_RD0003\_25\_56\_20150309\_00044.jpg

Looking west at century plant on landside shoulder and slope.

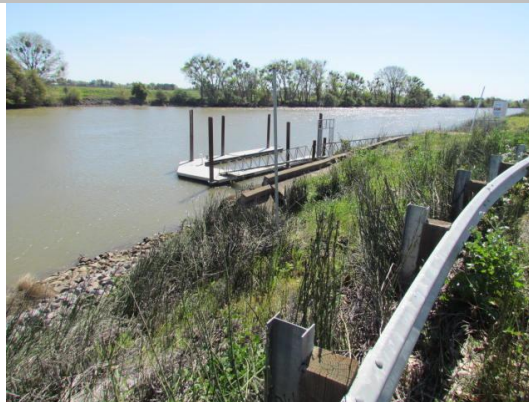
Photo 1 of 1 : SP\_2015\_RD0003\_25\_59\_20150309\_00046.jpg

Looking southeast at concrete structure on waterward slope.

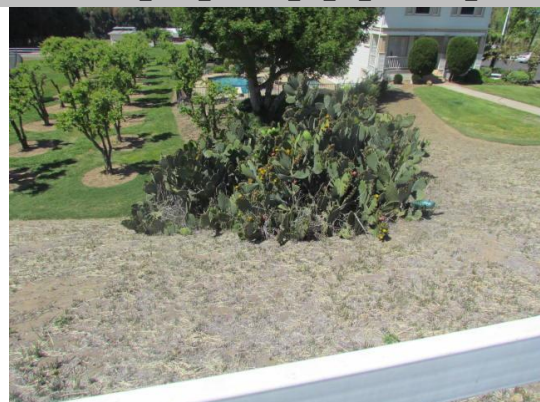
Photo 1 of 1 : SP\_2015\_RD0003\_25\_80\_20150309\_00061.jpg

Looking west at cactus on landward slope and toe.

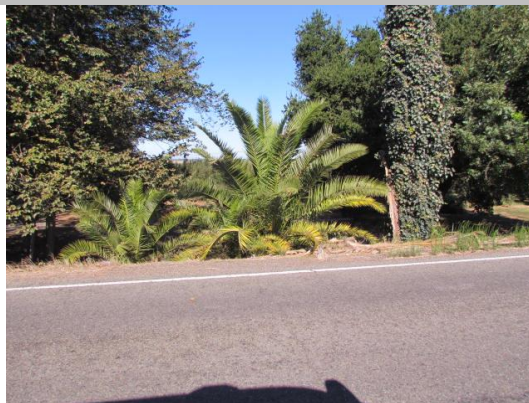
Photo 1 of 1 : SP\_2015\_RD0003\_25\_100\_20150309\_00074.jpg

Looking west at plam trees on landward shoulder and slope.

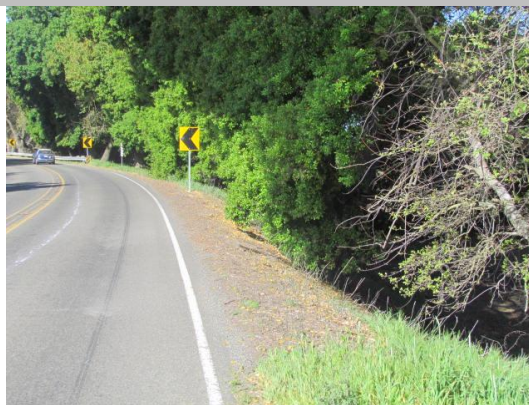
Photo 1 of 1 : SP\_2015\_RD0003\_25\_64\_20150318\_00094.jpg

Looking southwest at dense trees on landward shoulder and slope.

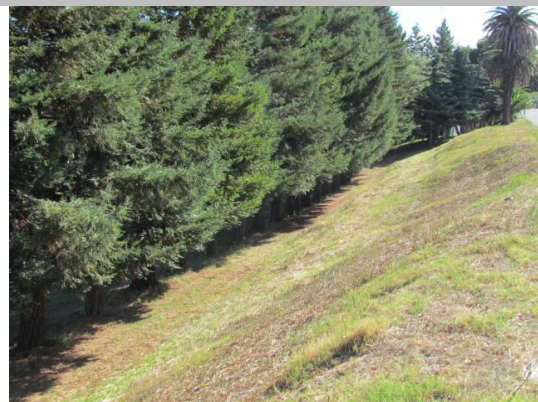
Photo 1 of 2 : SP\_2015\_RD0003\_25\_101\_20150309\_00075.jpg

Looking northwest at dense redwood trees on landward toe and berm.

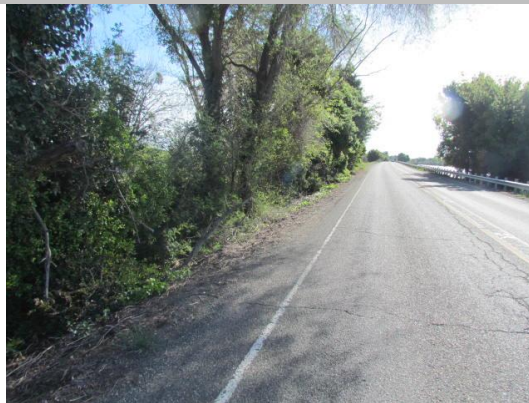
Photo 1 of 1 : SP\_2015\_RD0003\_25\_22\_20150318\_00096.jpg

Looking northwest at untrimmed trees on landward shoulder and slope.

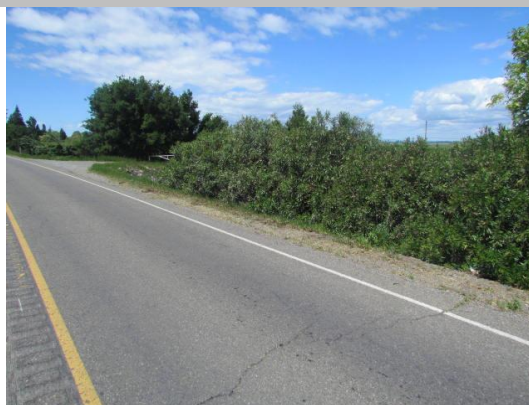
Photo 2 of 2 : SP\_2015\_RD0003\_25\_84\_20150309\_00065.jpg

Looking southwest at dense landscaping on landward shoulder and slope.

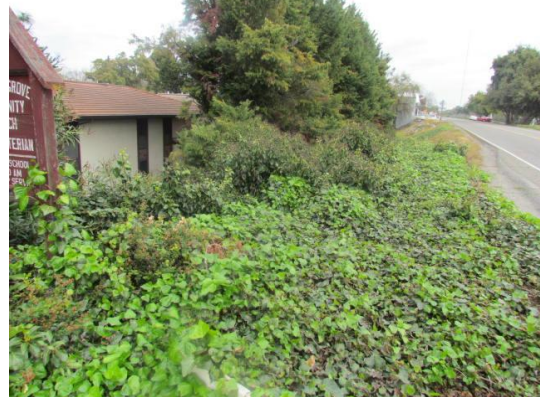
Photo 1 of 1 : SP\_2015\_RD0003\_25\_83\_20150309\_00064.jpg

Looking northwest at dense landscaping on landside shoulder and slope.

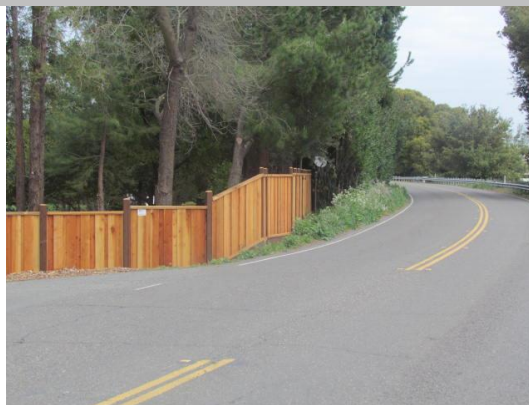
Photo 1 of 1 : SP\_2015\_RD0003\_25\_269\_20150309\_00083.jpg

Looking northwest at a new wooden fence on landside shoulder.

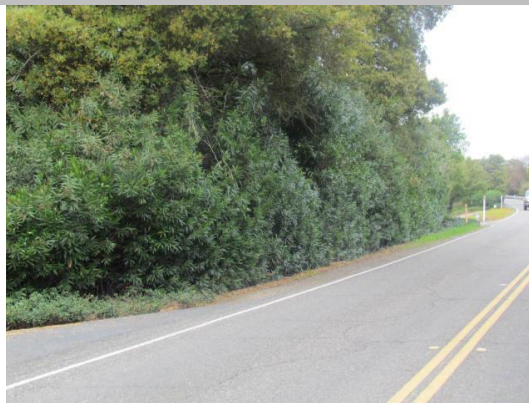
Photo 1 of 1 : SP\_2015\_RD0003\_25\_35\_20150309\_00034.jpg

Looking northwest at dense landscaping on landside shoulder and slope.

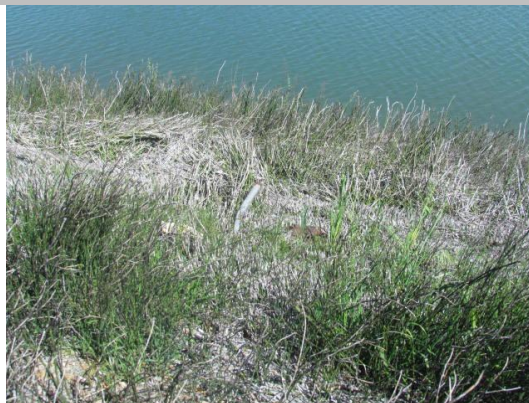
Photo 3 of 3 : SP\_2015\_RD0003\_25\_161\_20150318\_00103.jpg

Looking east at electrical conduits on waterward slope.

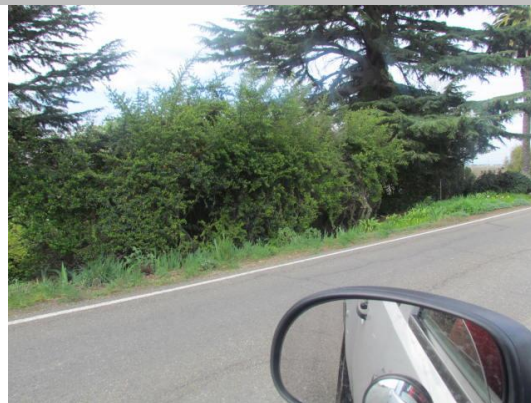
Photo 1 of 1 : SP\_2015\_RD0003\_25\_50\_20150309\_00040.jpg

Looking west at landscaping on landside slope.

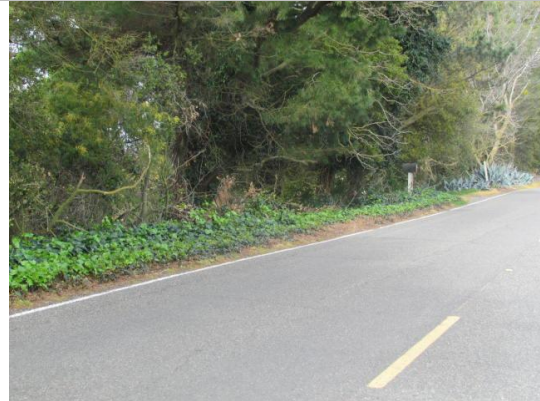
Photo 1 of 1 : SP\_2015\_RD0003\_25\_72\_20150309\_00053.jpg

Looking northwest at dense landscaping on landside shoulder and slope.

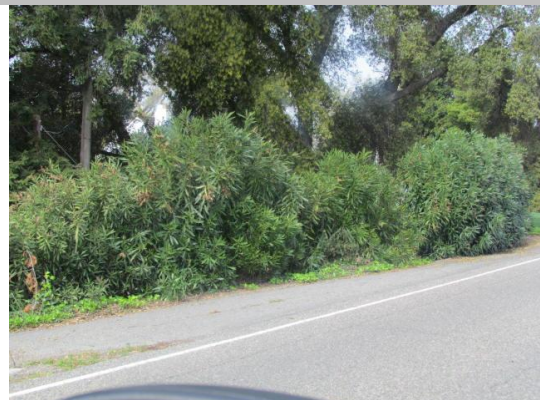
Photo 1 of 1 : SP\_2015\_RD0003\_25\_77\_20150309\_00057.jpg

Looking west at landscaping on landside shoulder and slope.

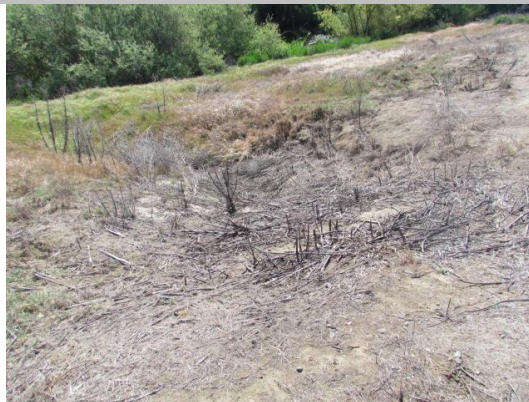
Photo 2 of 3 : SP\_2015\_RD0003\_610\_3\_20150309\_00002.jpg

Looking east at depression on landward slope.

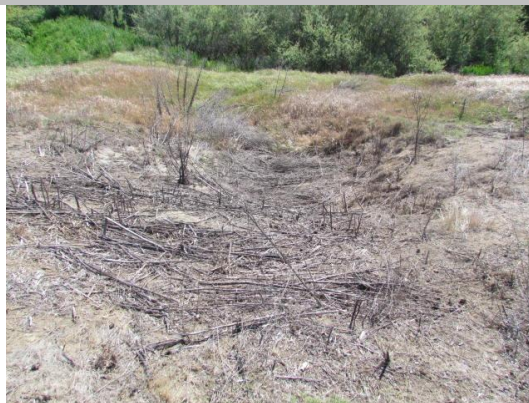
Photo 3 of 3 : SP\_2015\_RD0003\_610\_3\_20150309\_00003.jpg

Looking north on depression on landward slope.
